Ovako Imatra - Case Study Report of a heavy duty Industrial gear restored with RVS Technology treatment.

The device in question is a Drift Gear, location: 6040KÄ01, Gear brand: Danieli, type: GPR.550.13, number 77.78.623

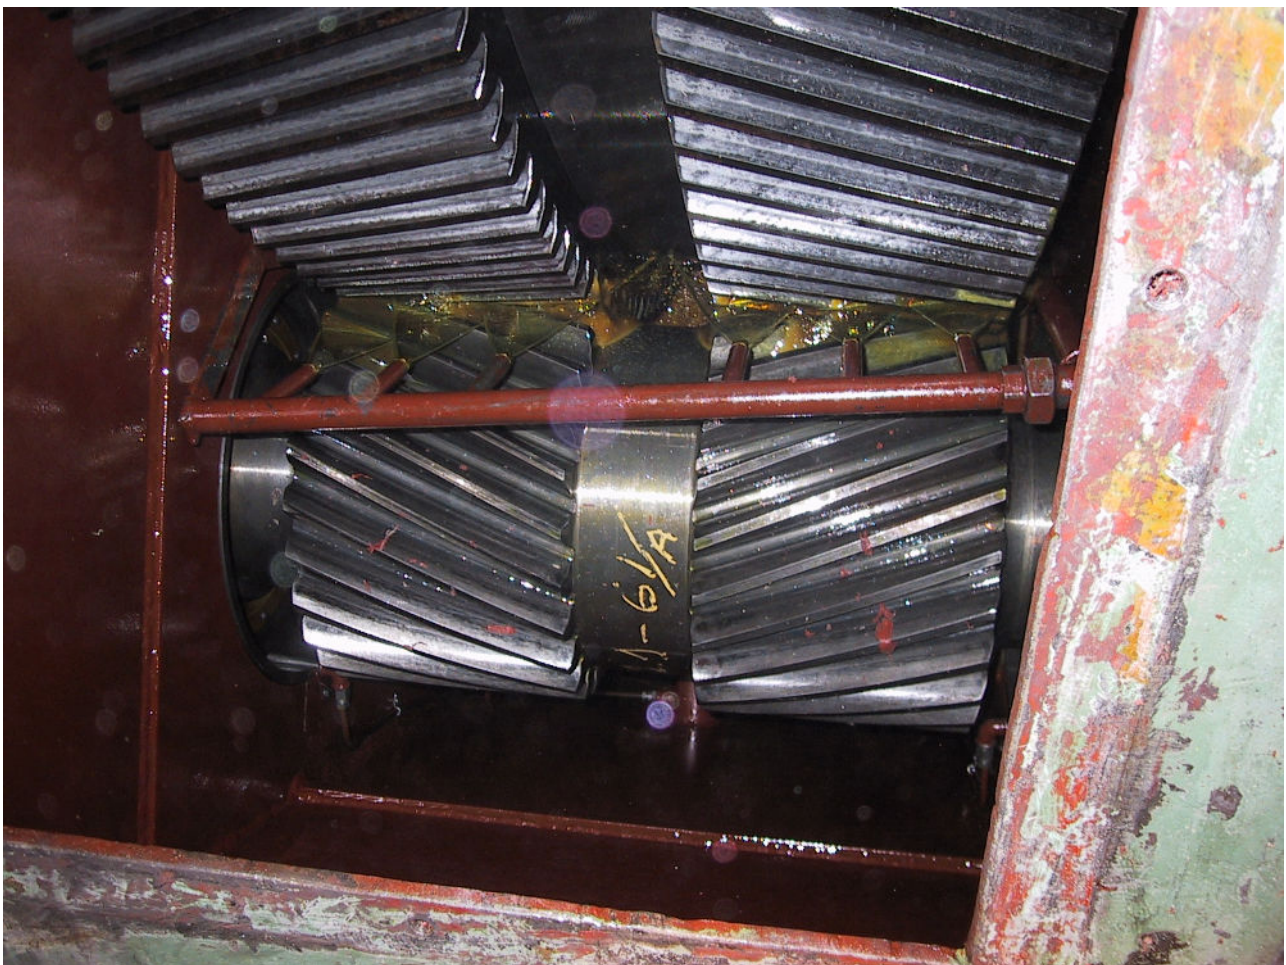
27.09.2003, the "motor side" gear

Below pictures of the teeth of a double-helical gear of a Drift Gear countershaft of a Roller Mill owned by Ovako Imatra, a major steel company in Finland. TriboCeramic (sometimes also called Metal Ceramic, Ferrocilicate) layers produced by the RVS Technology compound can be observed on the gear teeth.

The gear is from 1971. The teeth were in bad shape and serious pitting was detected on the surfaces of the teeth. The manufacturer quoted a new gear to a price ca. 0.8 Million Euro and a delivery time over one (1) year. In these circumstances the company decided to try the efficiency of RVS Technology Protection & Restoration technology products.

Traces of earlier strong pitting are detected. The pictures show that the teeth have now partly been covered with TriboCeramic compound. TriboCeramics area has been marked with red color on some teeth. The existence of the ceramic appears as a polished area around and on the pitting pits. The pits are "filled and leveled" with TriboCeramics.

The pictures show that no changes have taken place on the teeth within the almost ten (10) years period. No traces of wear were detected in the last inspection, 2011. This proves that the TriboCeramic surface is solid and permanently integrated to the contact surfaces of the teeth. The cost of the RVS treatment, year 2003, was ca. 12,000 Euro.

Pictures have been taken in three sequences, 27.9.2003, 21.5.2005 and 10.12.2011. The RVS Technology treatment was carried out on 11.3.2003 by applying RVS compound into the oil tank that locates ca. 10 m away from the gear. The oil filter was by-passed during the first eight (8) treatment hours. The situation before RVS application was not pictured.
