Fraunhofer Technologie-  
Entwicklungsgruppe

## Project report:

## **Test of the validity of RVS-technology® gel**

Prepared in December 2003 by:

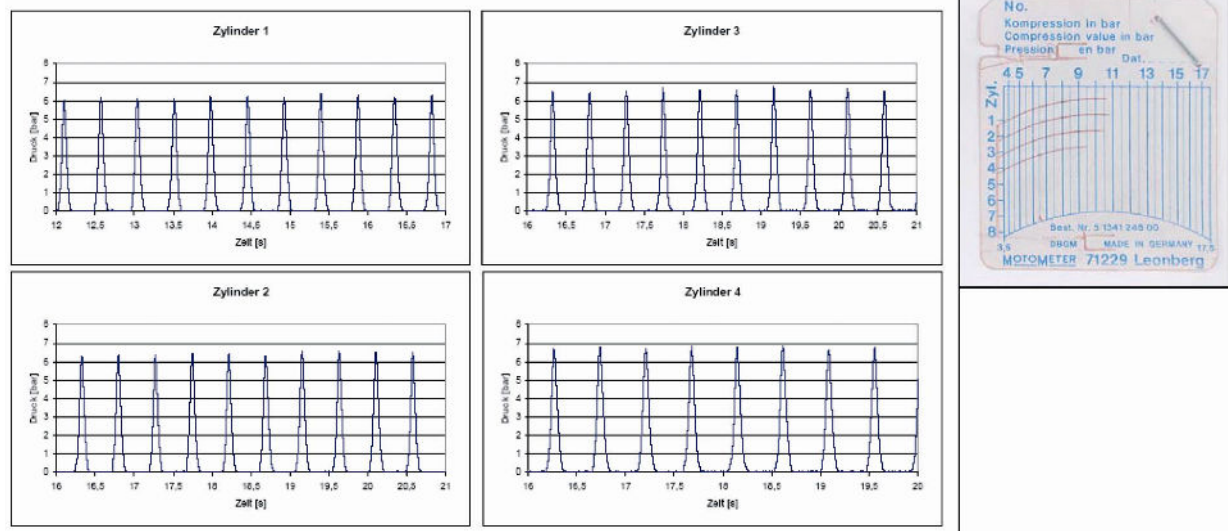
Figure 4-6: Results of compression measurement (digital measurement on left, analogy measurement at top right)

Compression measurements by the Technical Control Board of Böblingen prior to application of RVS-technology® gel at a mileage of 19,441 kilometres yielded the compression characteristics shown in Figure 4-6. The average peak value lies in the region of 6.5 bar. The differences between the results of the two measurement techniques are attributable to the nature of the techniques. However, both of them are a tried and tested means of evaluating characteristics.

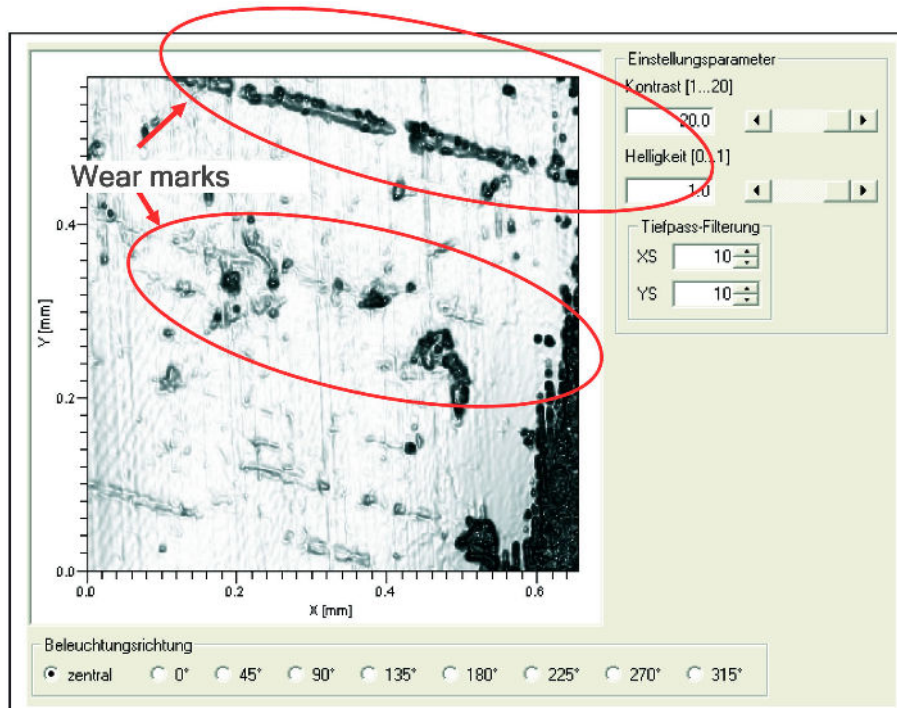
Figure 4-9: Recording (top view) of a cylinder wall by means of a white-light interferometer (with artificial lighting)

An optical analysis of the cylinder surface reveals no significant signs of damage. The cylinder wall is smooth, exhibiting a few wear marks in the form of axial grooves, this number lying within reasonable limits.

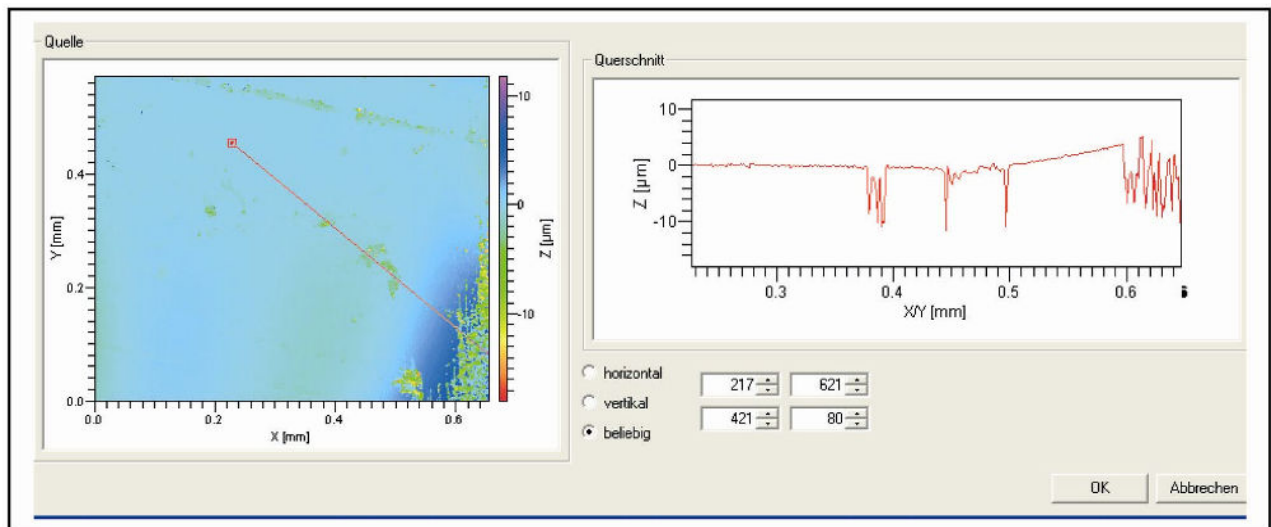
Figure 4-10: Recording of a cross-section by means of a white-light interferometer

Figures 4-10 and 4-11 provide explicit representations of a cross-section quantifying the structure and course of the marks. These marks have a real depth of up to 8  $\mu\text{m}$ . Depths exhibited in excess of this value are attributable to the measuring inaccuracies (diffraction effects) of this technique ( $R_a = 6.6$  /  $R_z = 0.83$ ).

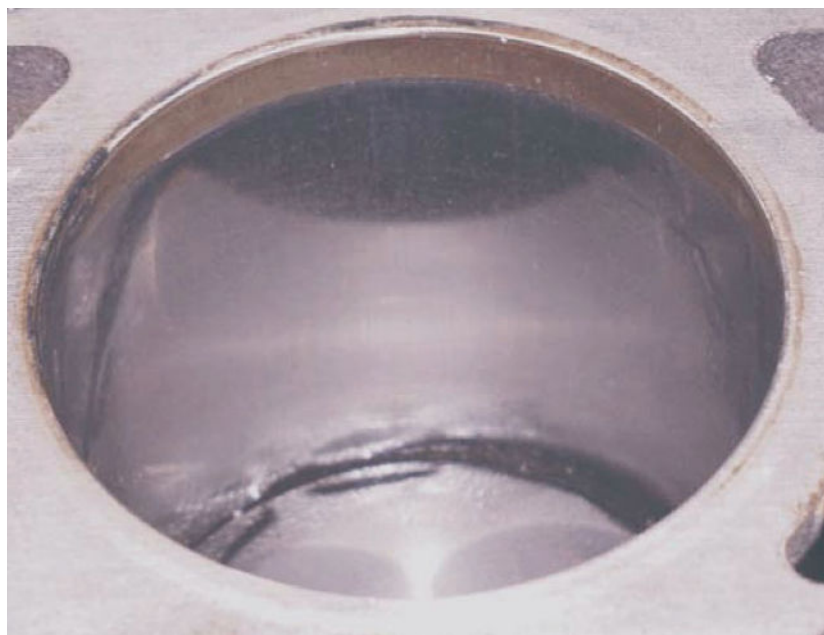
Figure 5-1: Digital recording of the Ford Escort's engine block following treatment (alterations to the surface are clearly visible)

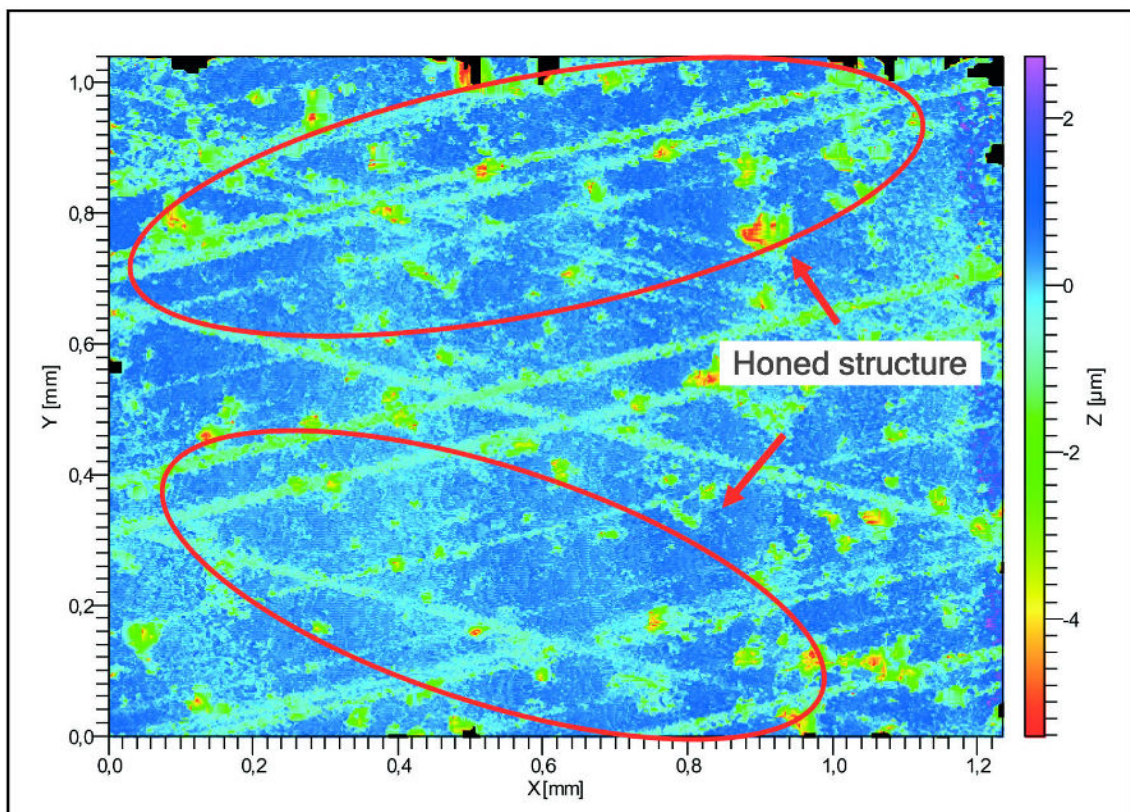
Figure 5-4: Recording (top view) of a cylinder wall using a white-light interferometer

These recordings show the structure of the cylinder surface. Evidently, the surface has a typical, honed texture.

A comparison between the measurement results in Figures 5-4 and 4-8 verifies the presence of a material layer of 4-5  $\mu\text{m}$ . The colour scales indicate a maximum mark depth of 8-9  $\mu\text{m}$  in Figure 4-8 and 3-4  $\mu\text{m}$  in Figure 5-4. This difference is attributable to the application of RVS-technology® gel. A change in the scale of representation (based on the deepest mark) also reveals honed textures in the second measurement series.

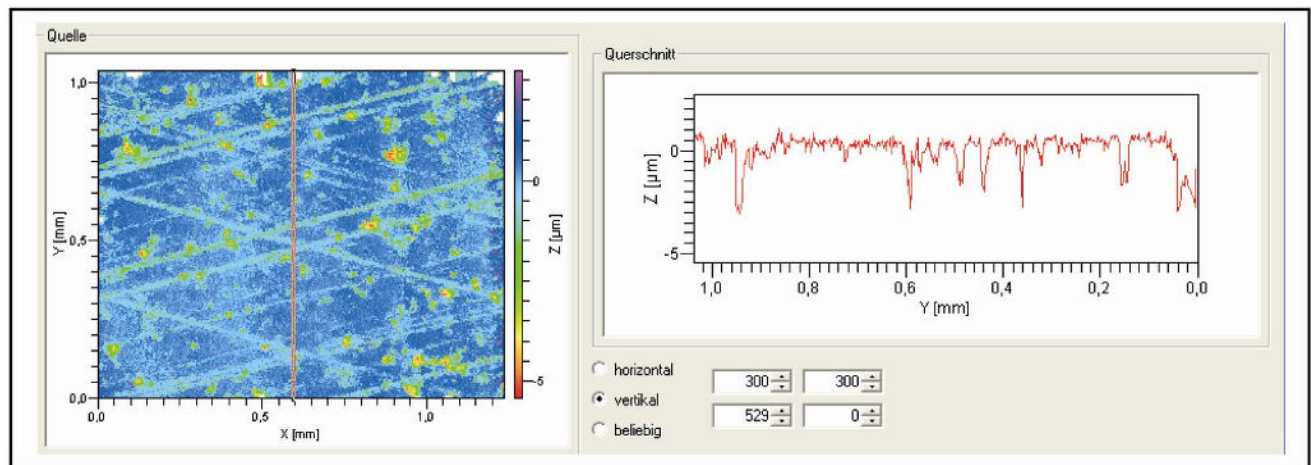
Figure 5-5: Recording of a cross-section by means of a white-light Interferometer

Figure 5-5 provides an explicit representation of a cross-section quantifying the structure and course of the marks. These marks have a depth of 2 - 3  $\mu\text{m}$  ( $R_a = 1.2 / R_z = 0.12$ ).

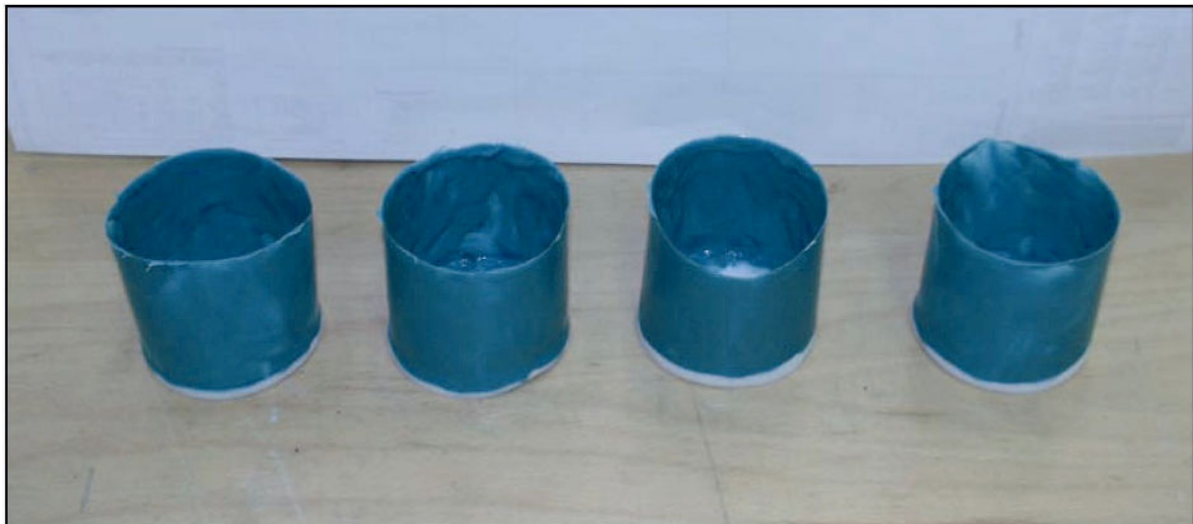
Figures 6-1 und 6-2 show the four cylinder casts before and after application of RVS-technology® gel.

This test is exclusively intended for a qualitative evaluation of changes in surface structure. The cylinder surface exhibited improvement in the form of reduced wear marks.

Figure 6-1: Cylinder casts before treatment

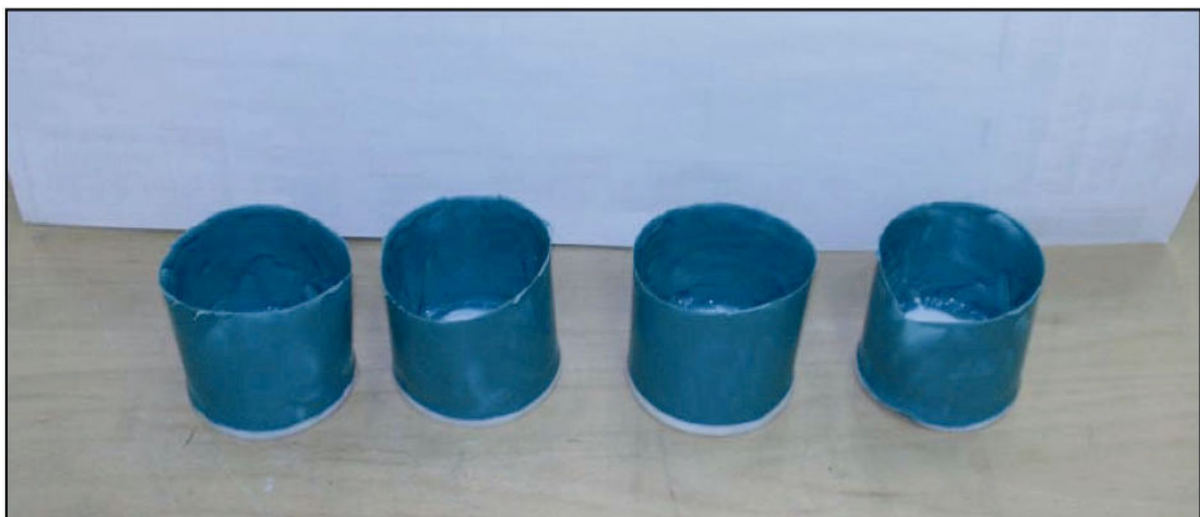
Figure 6-2: Cylinder casts after treatment
